PUBLIC SAFETY MEASURES PLAN

BALA FALLS DAMS

FINAL REPORT

WESA File No. OE7935-12

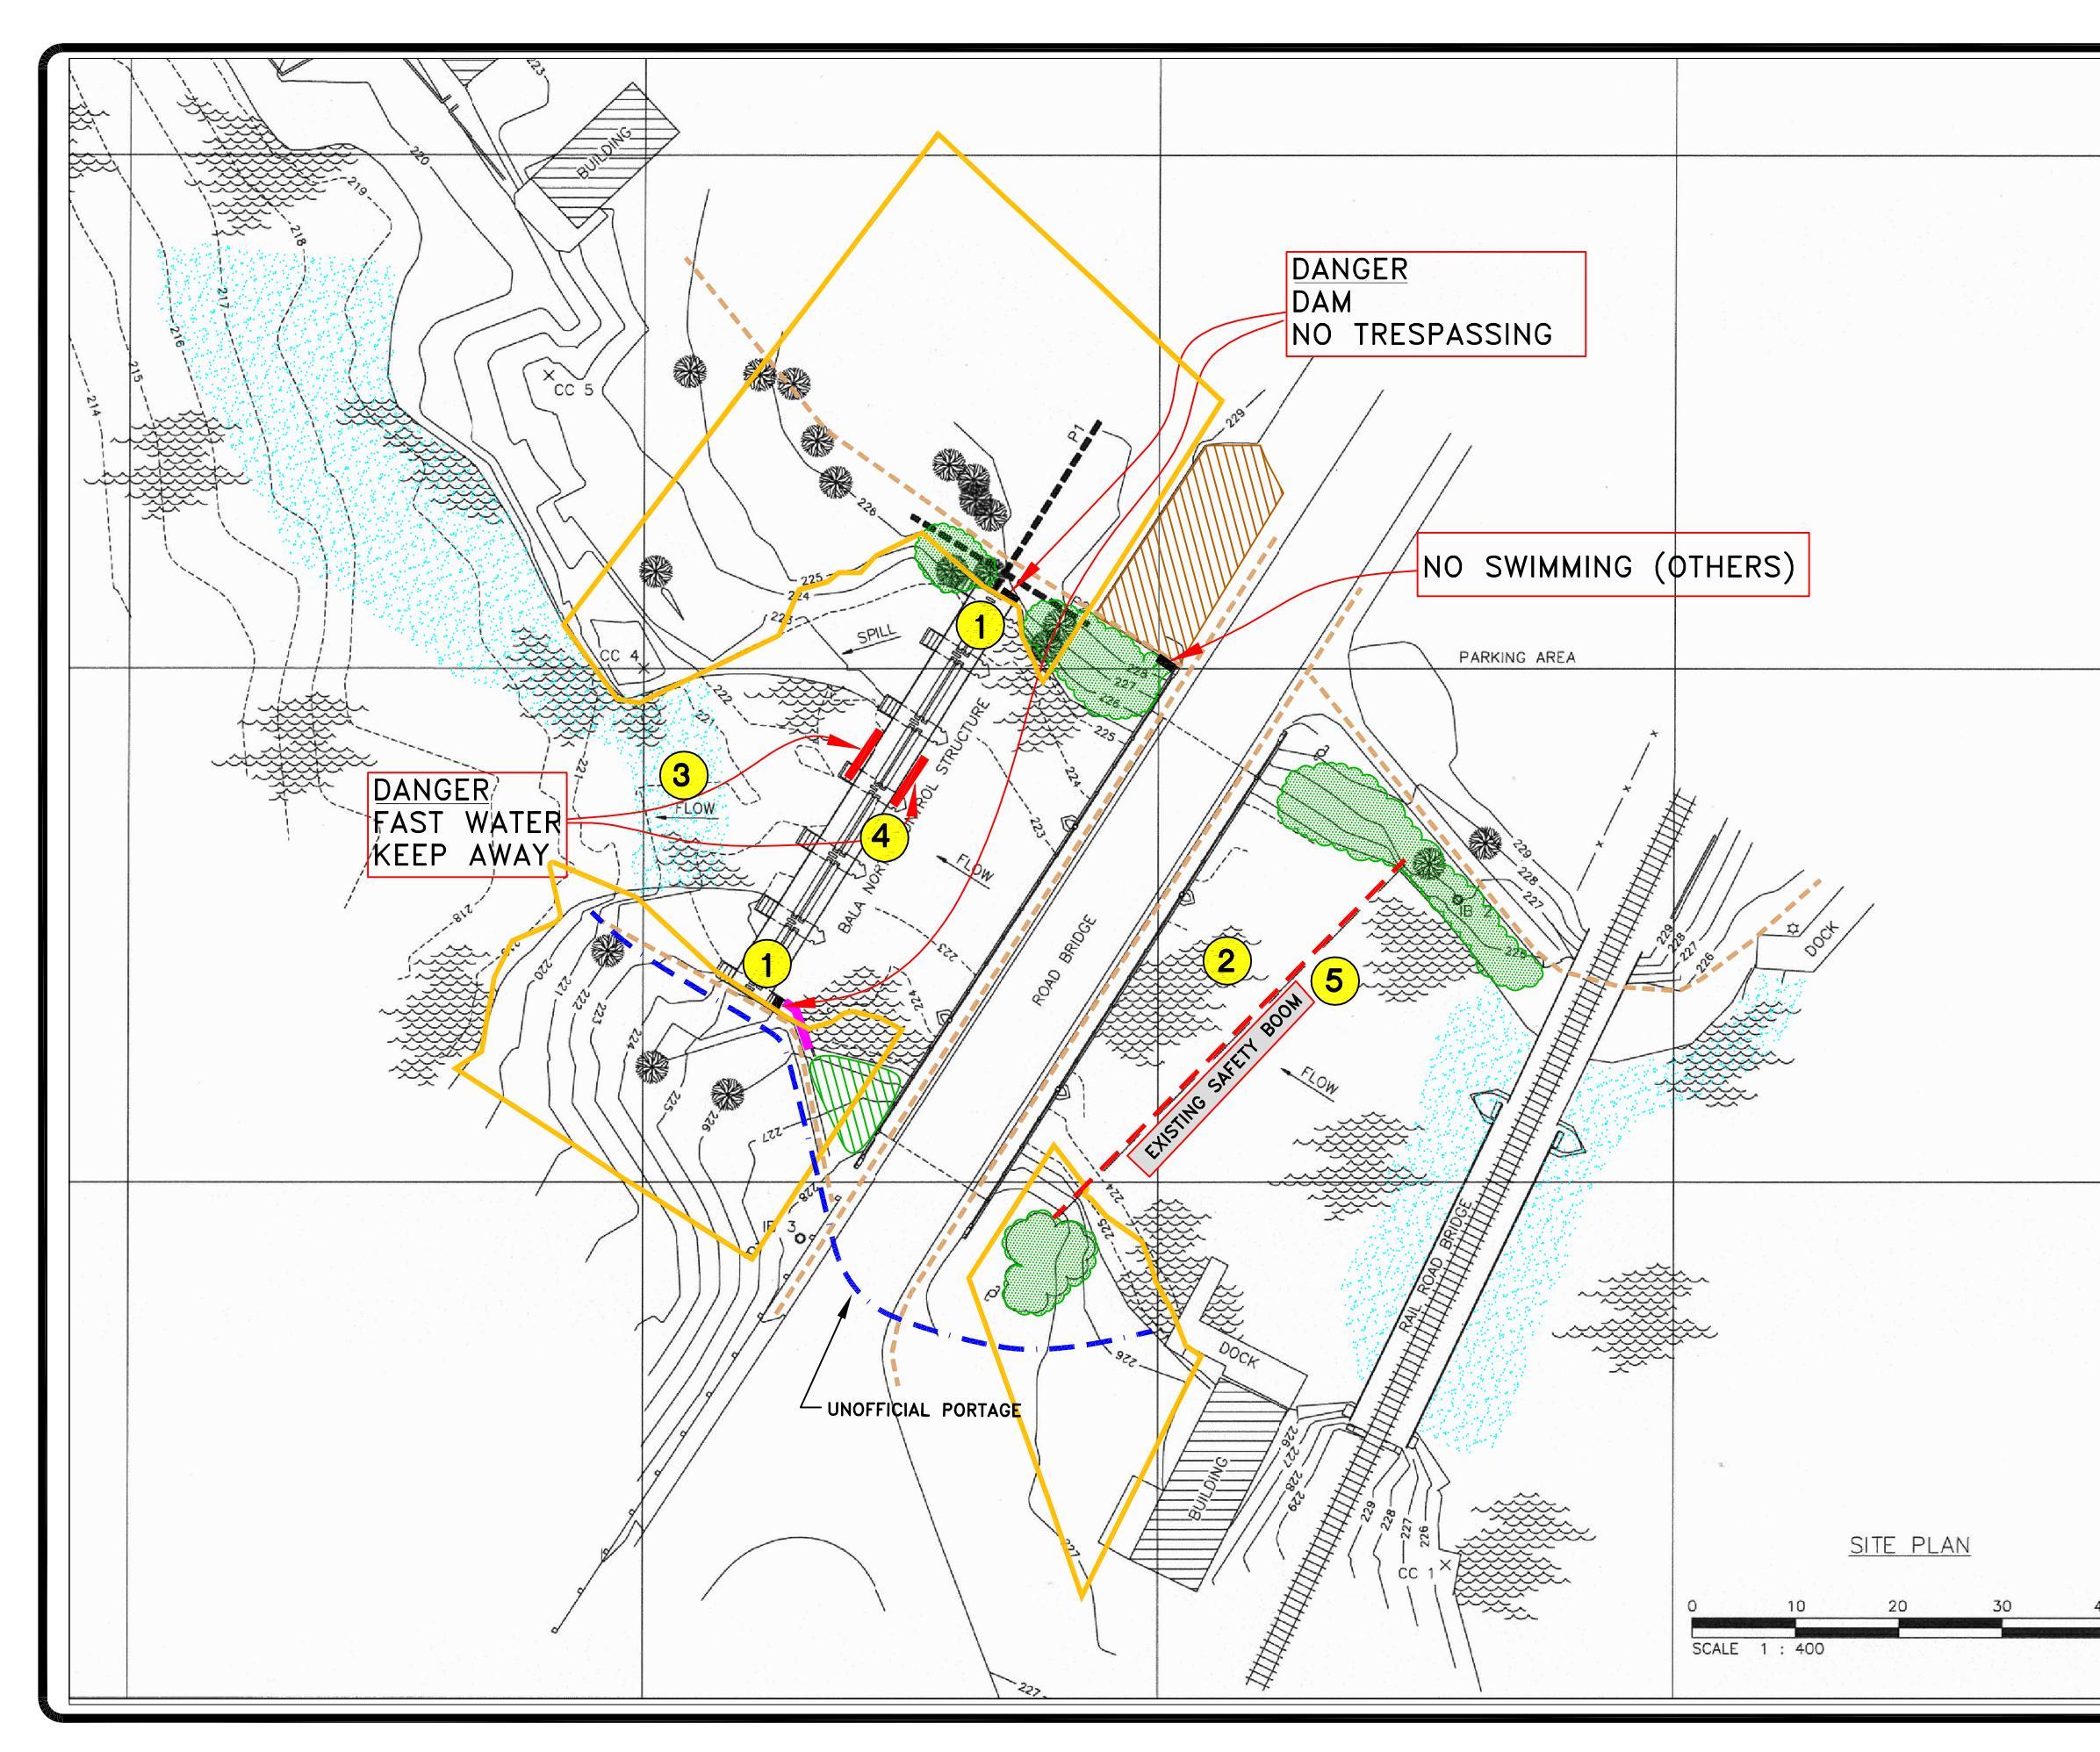
A summary of the hazards identified is listed in Tables 1 and 2 below for each dam. The identified hazards are also displayed on Figures 1 and 2 in Appendix A. Figure 3 in Appendix A shows the approximate dangerous water areas for the Bala Falls Dams site.

Table 1:	North Dam Identified Hazards
Hazard	Hazard Description
Number on	
Site Plan	
(Figure 1)	
1	Trespass onto dam, Falls
2	Swimming in upstream dangerous water area, Drowning
3	Wading / swimming in downstream dangerous water area, Drowning
4	Paddling through the dam, Capsize, Drowning
5	Swimming in upstream dangerous water area upstream of safety boom,
	Drowning

Warning signage is recommended along both shorelines of the North Dam (see Figure 1) to safely guide the public around hazardous areas;

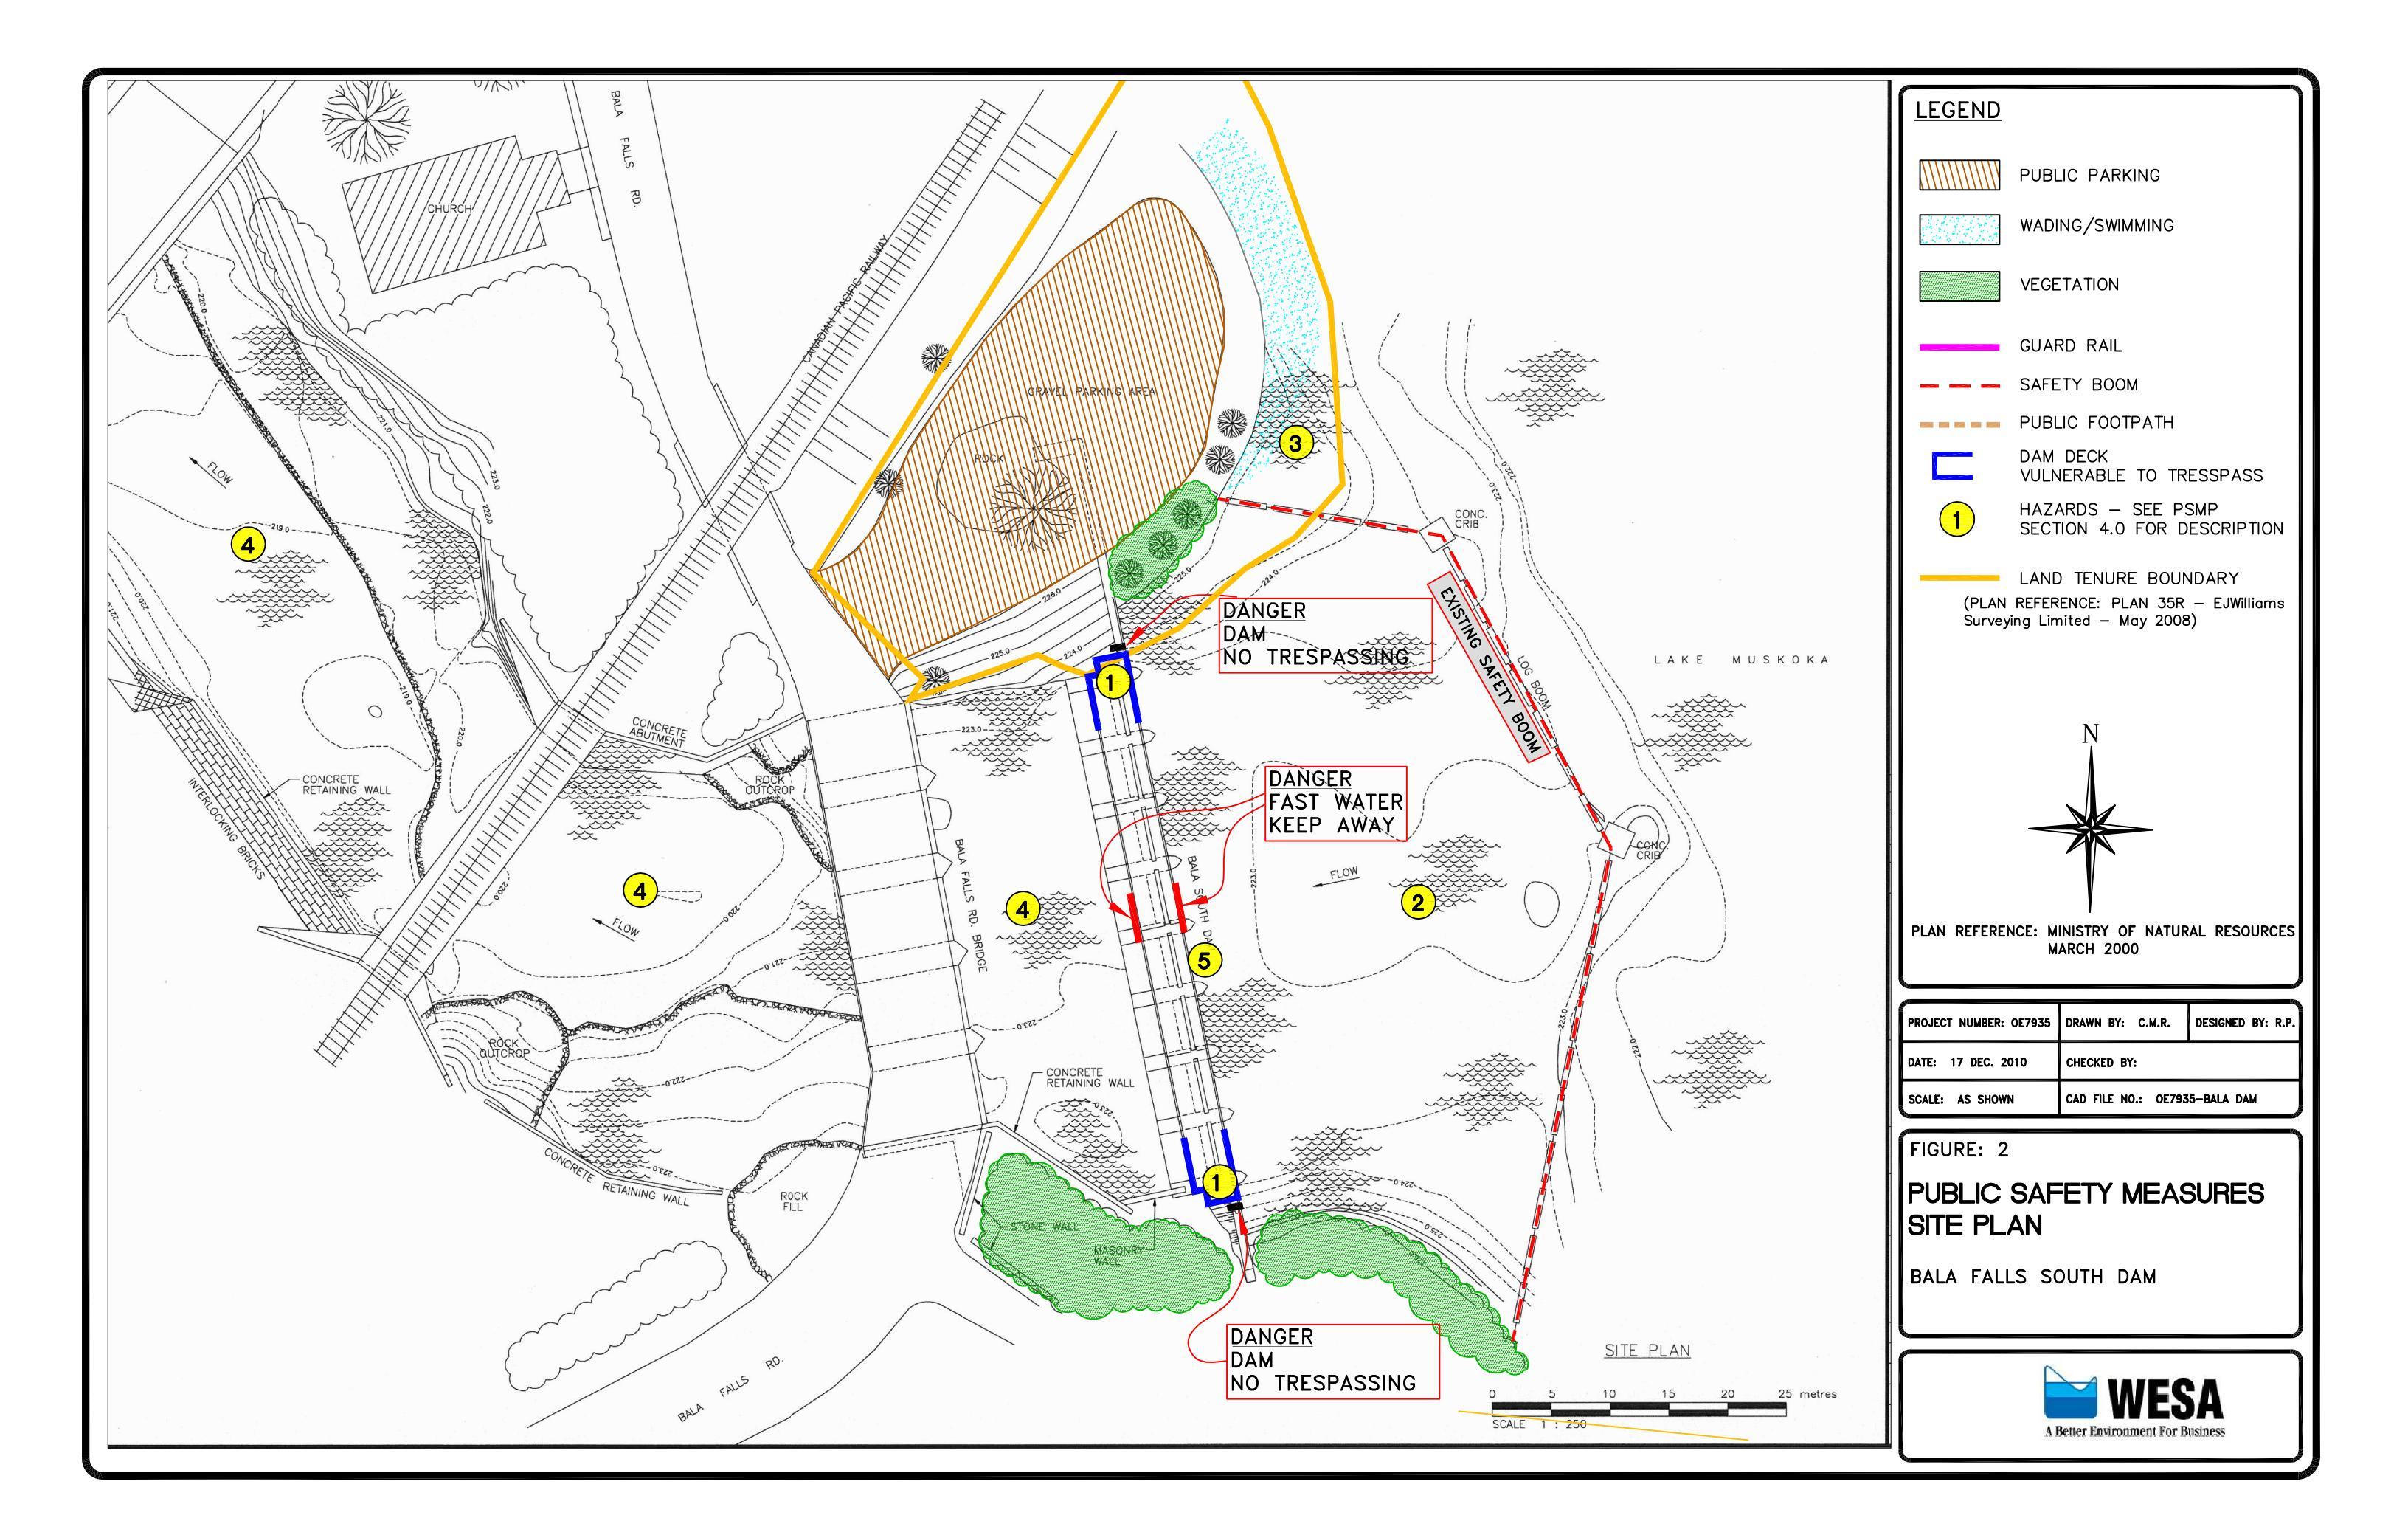
Hazard	Hazard Description	
Number on		
Site Plan		
(Figure 2)		
1	Trespass onto dam, Falls	
2	Swimming in upstream dangerous water area, Drowning	
3	Wading / Swimming in areas upstream of existing boom yet within the	
	calculated dangerous water area, Drowning	
4	Wading / swimming in downstream dangerous water area (spillway),	
	Drowning	
5	Paddling through dam, Drowning

At the South Dam site warning signs are recommended (see Figure 2);

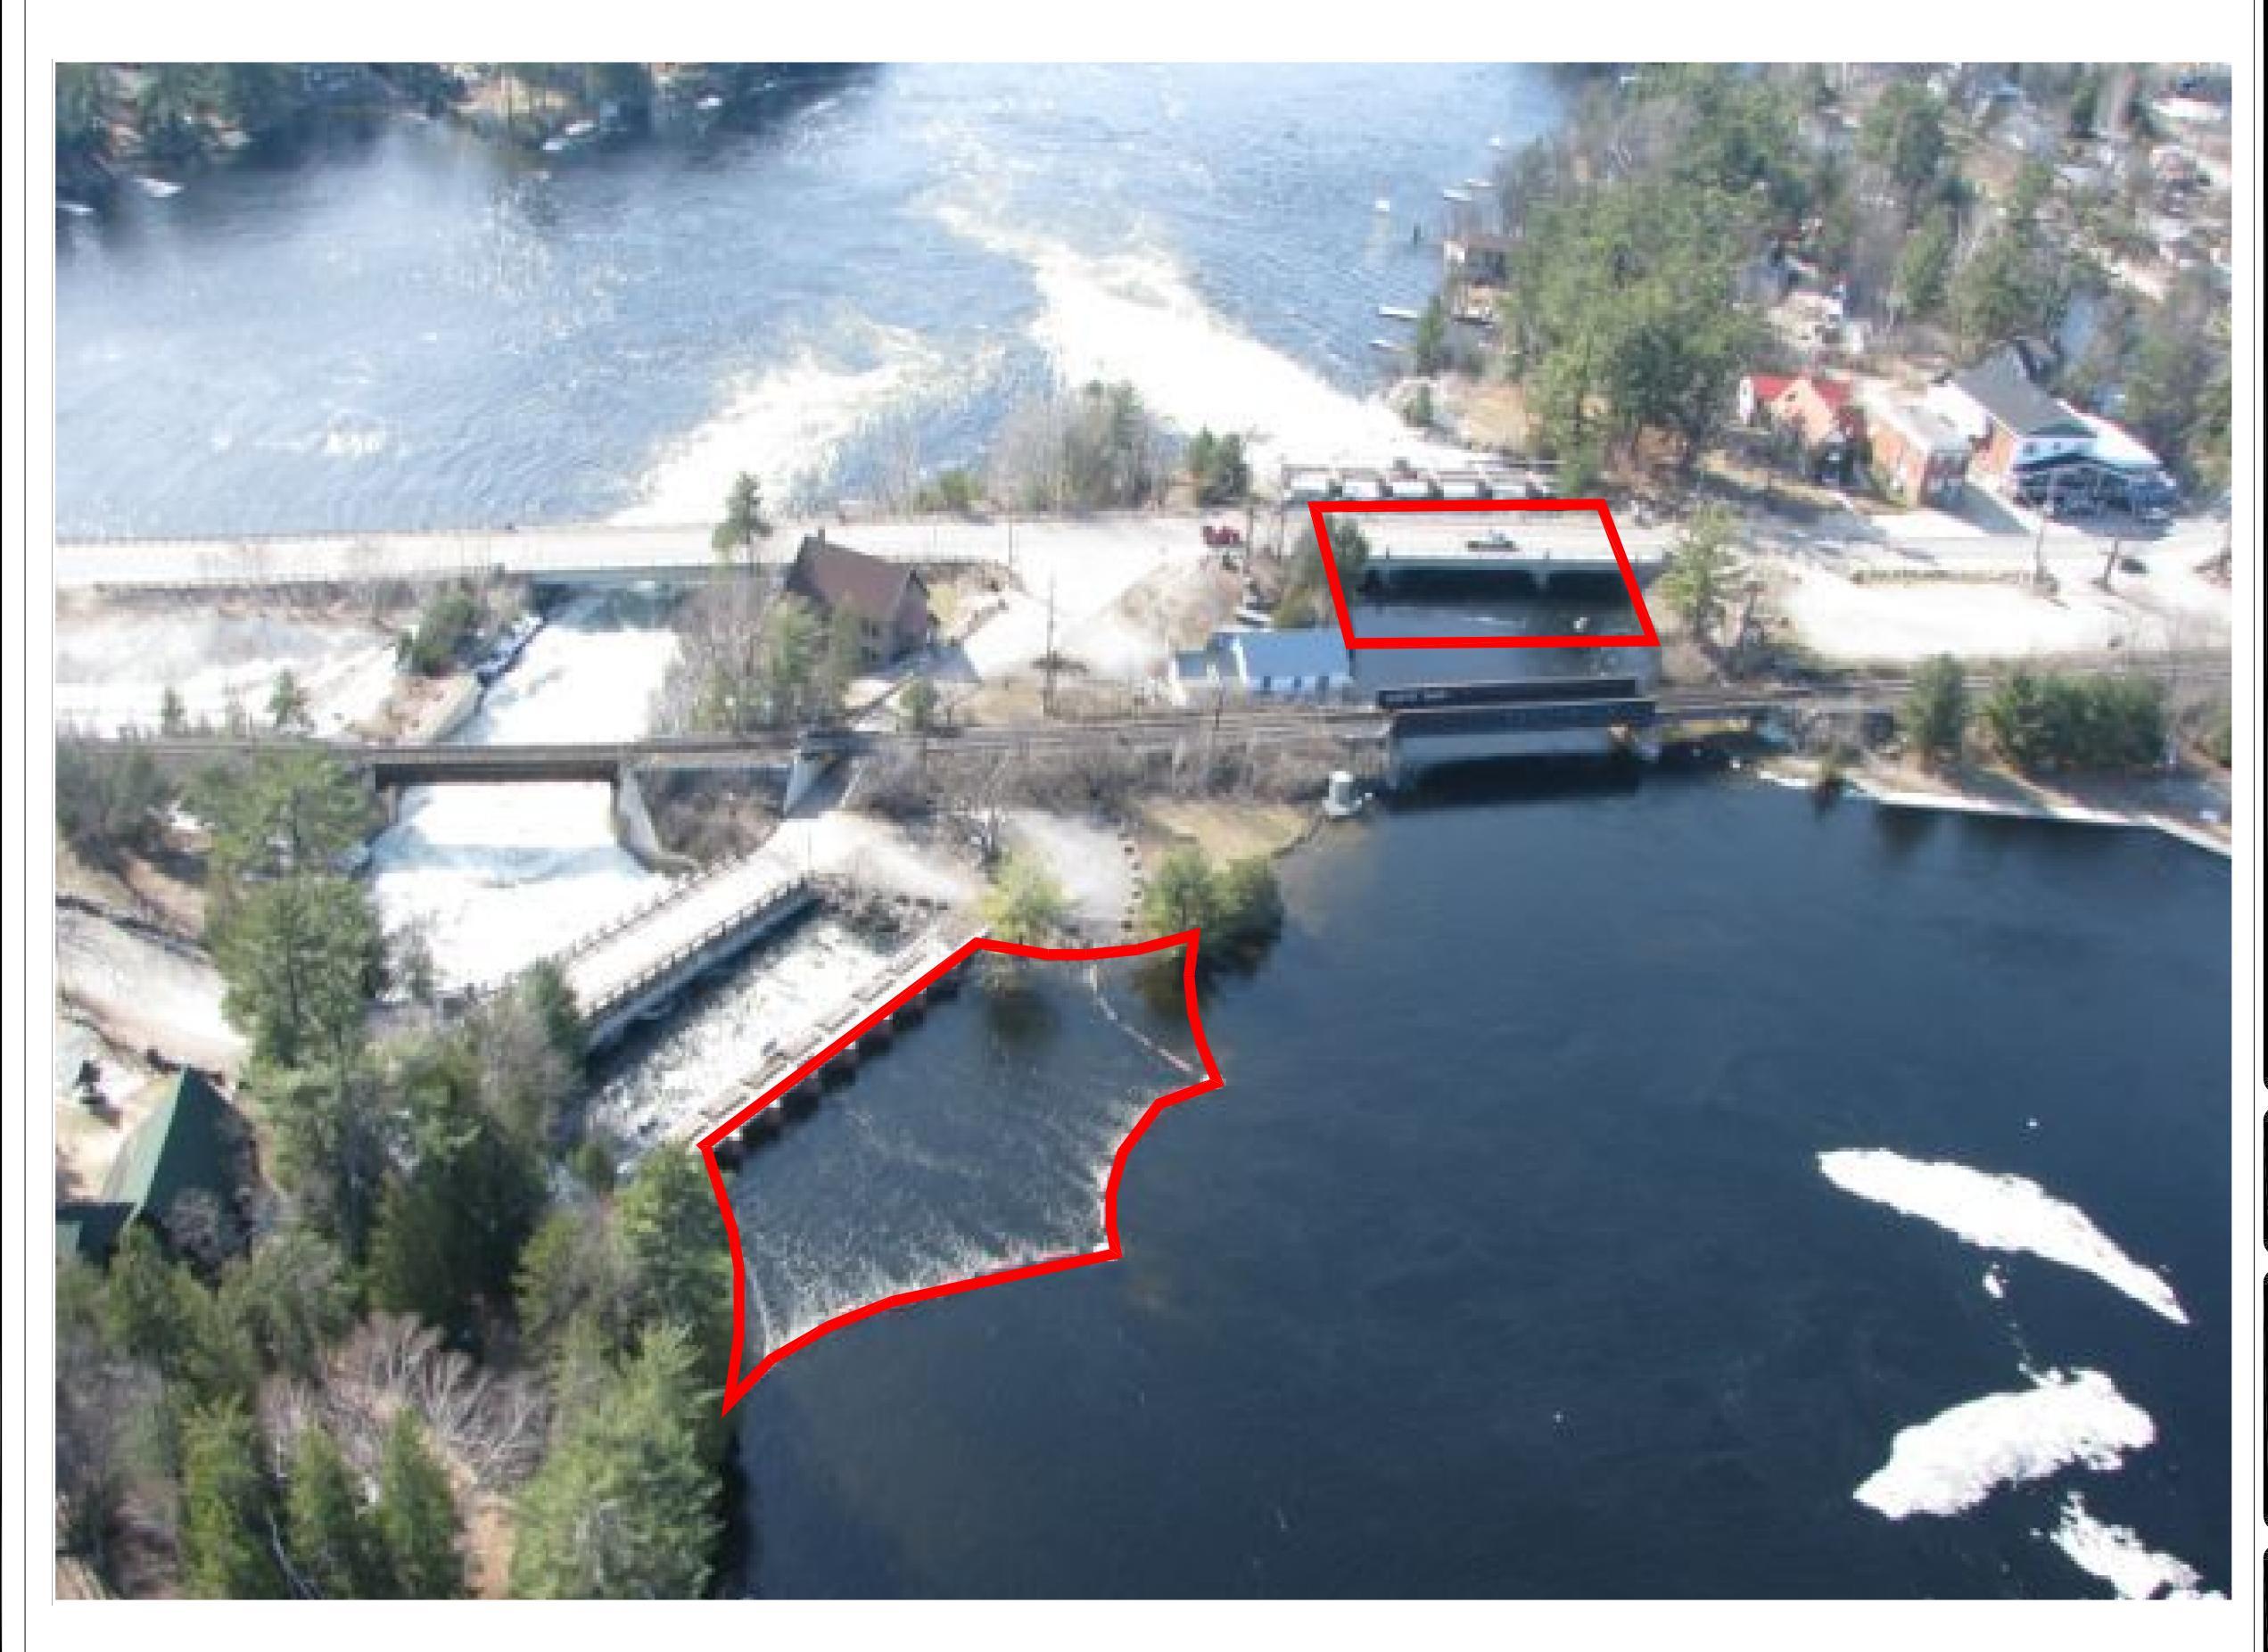
The downstream waterway areas that may be influenced by dam operations can be conservatively estimated to roughly correspond to the white water areas immediately downstream of the dam structures and extending out into the Moon River under high flow conditions.
