PROJECT NO. 131-13550-00

# BALA GENERATING STATION PUBLIC SAFETY MEASURES PLAN

REPORT REVISION 4

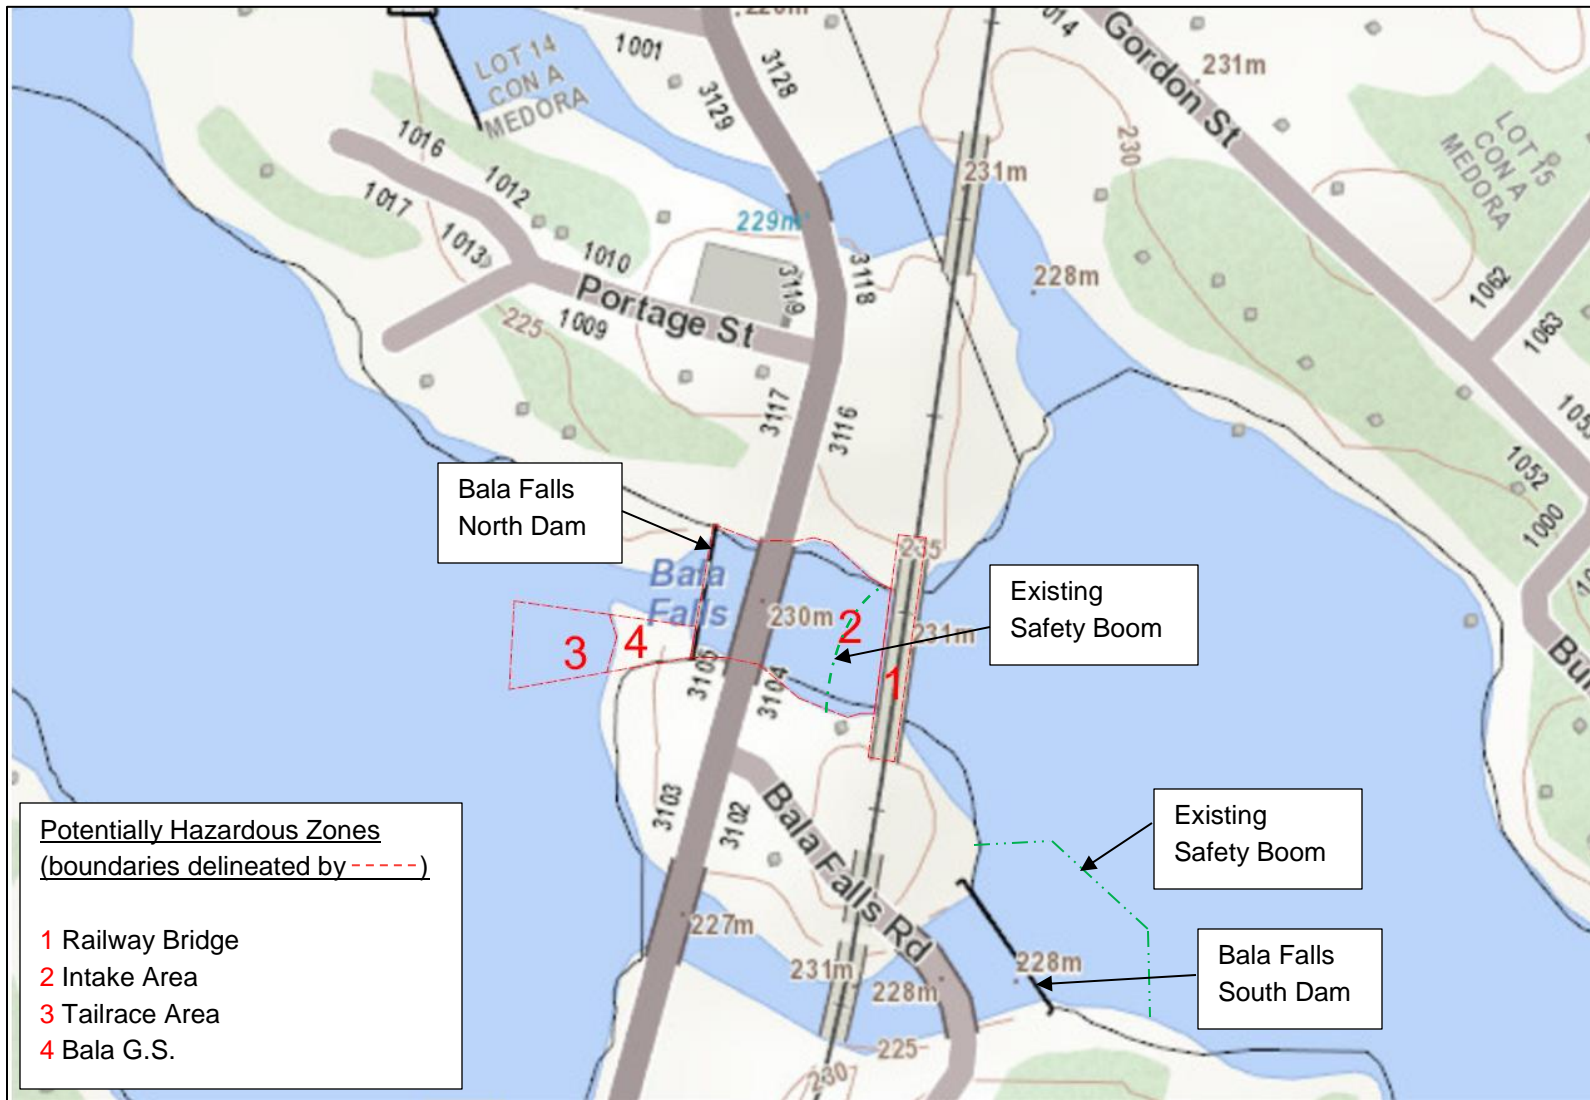
**Figure 1 Potential hazards at the Bala Falls site**

From a public safety perspective, there are several potentially hazardous zones at the Bala Falls site as shown in Figure 1 including:

- 1 The railway bridge
- 2 The intake area upstream of the powerhouse
- 3 The tailrace area downstream of the powerhouse, and
- 4 The Bala Falls G.S.

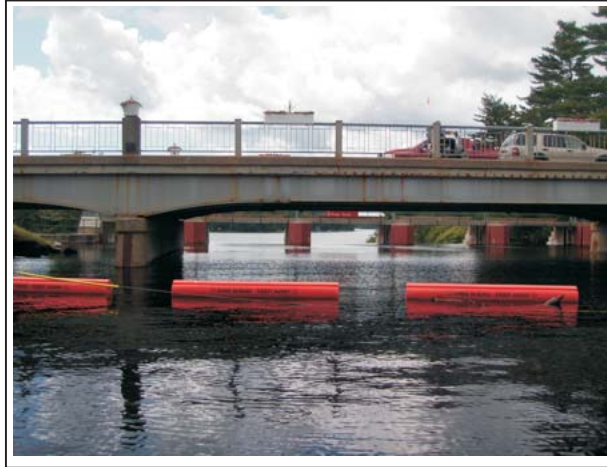
to each gate. Larger English-language signs reading “DANGER Fast Water Keep Away” are located on both faces of the dam, mounted to the railings. All signage was MNR standard issue and was observed to be in good condition. The view of the DANGER sign mounted on the upstream face was obstructed by the road bridge.

FROM UPSTREAM, DAM SHOWING OBSCURED DANGER SIGN

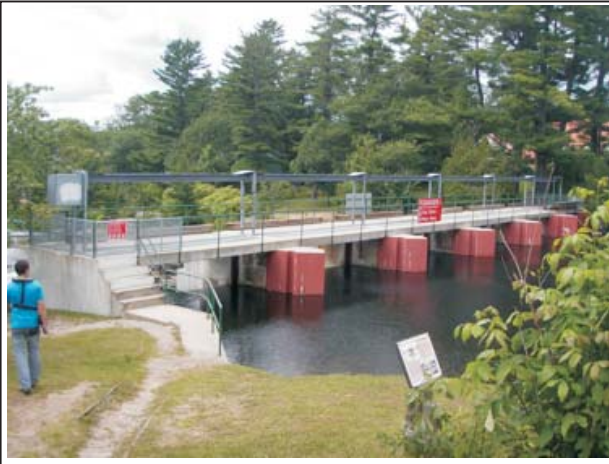
FROM UPSTREAM, DAM SHOWING MESHED GUARDRAIL ENDS AND DANGER SIGNS

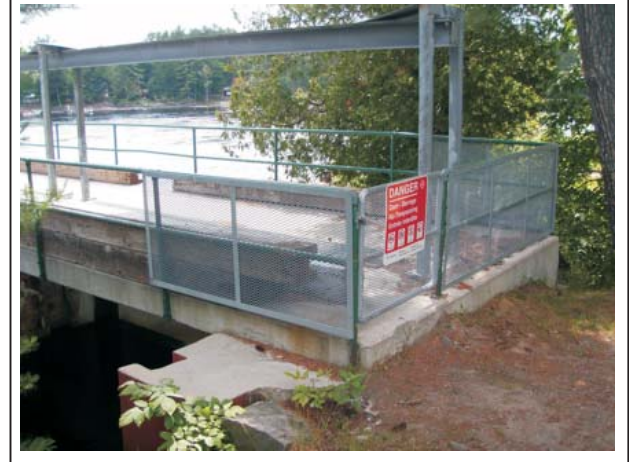
MESHED GUARDRAIL AND DANGER SIGN, NORTH END

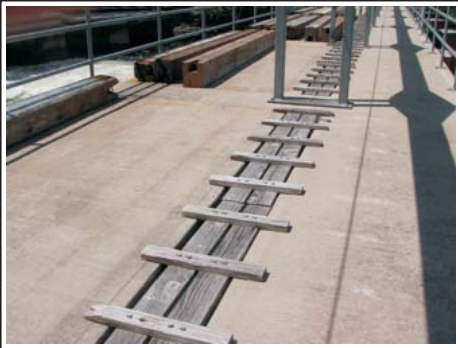
DAM DECK WITH UNSECURED STOPLOG GAIN COVERS
